NASA Technical Memorandum 86347

**DIRECT-STRIKE LIGHTNING PHOTOGRAPHS,
SWEPT-FLASH ATTACHMENT PATTERNS,
AND FLIGHT CONDITIONS FOR
STORM HAZARDS '82**

**Klaus P. Zaepfel,
Bruce D. Fisher,
and Merle S. Ott**

February 1985

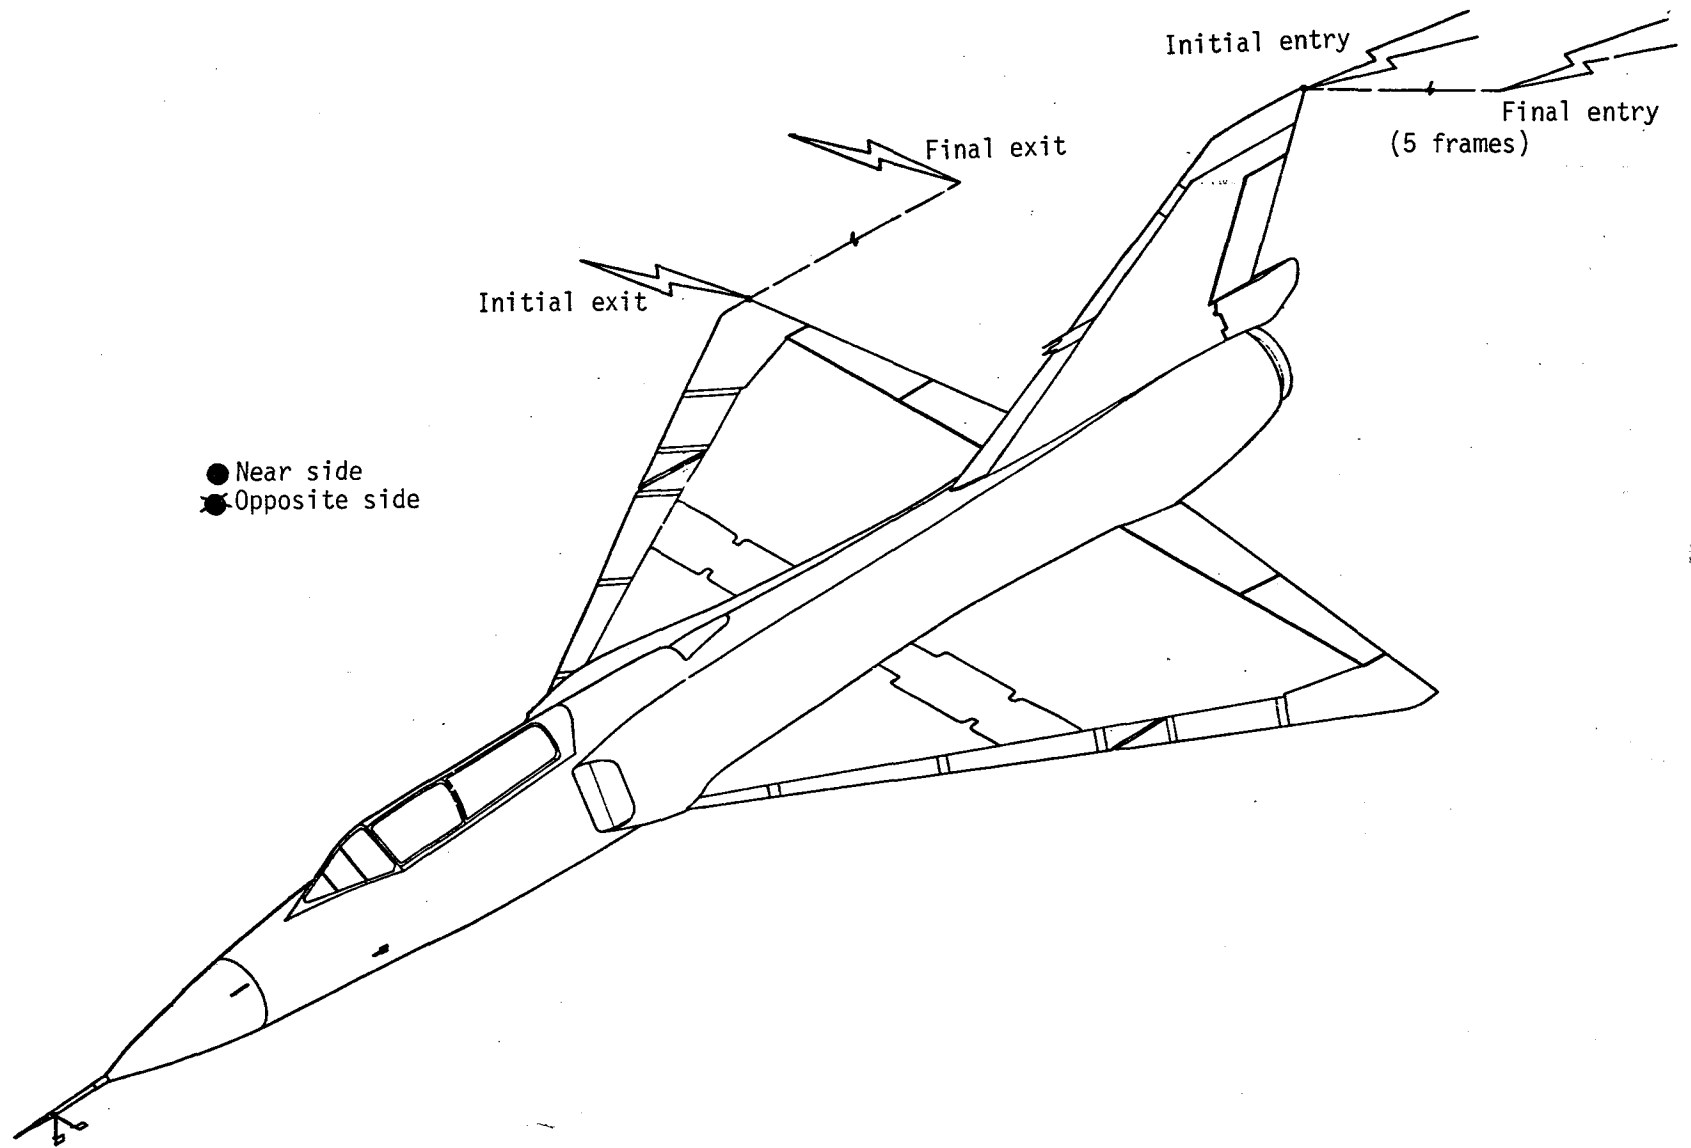
Figure 152.- Lightning attachment points and scenario for strike 139, Flight 82-044.

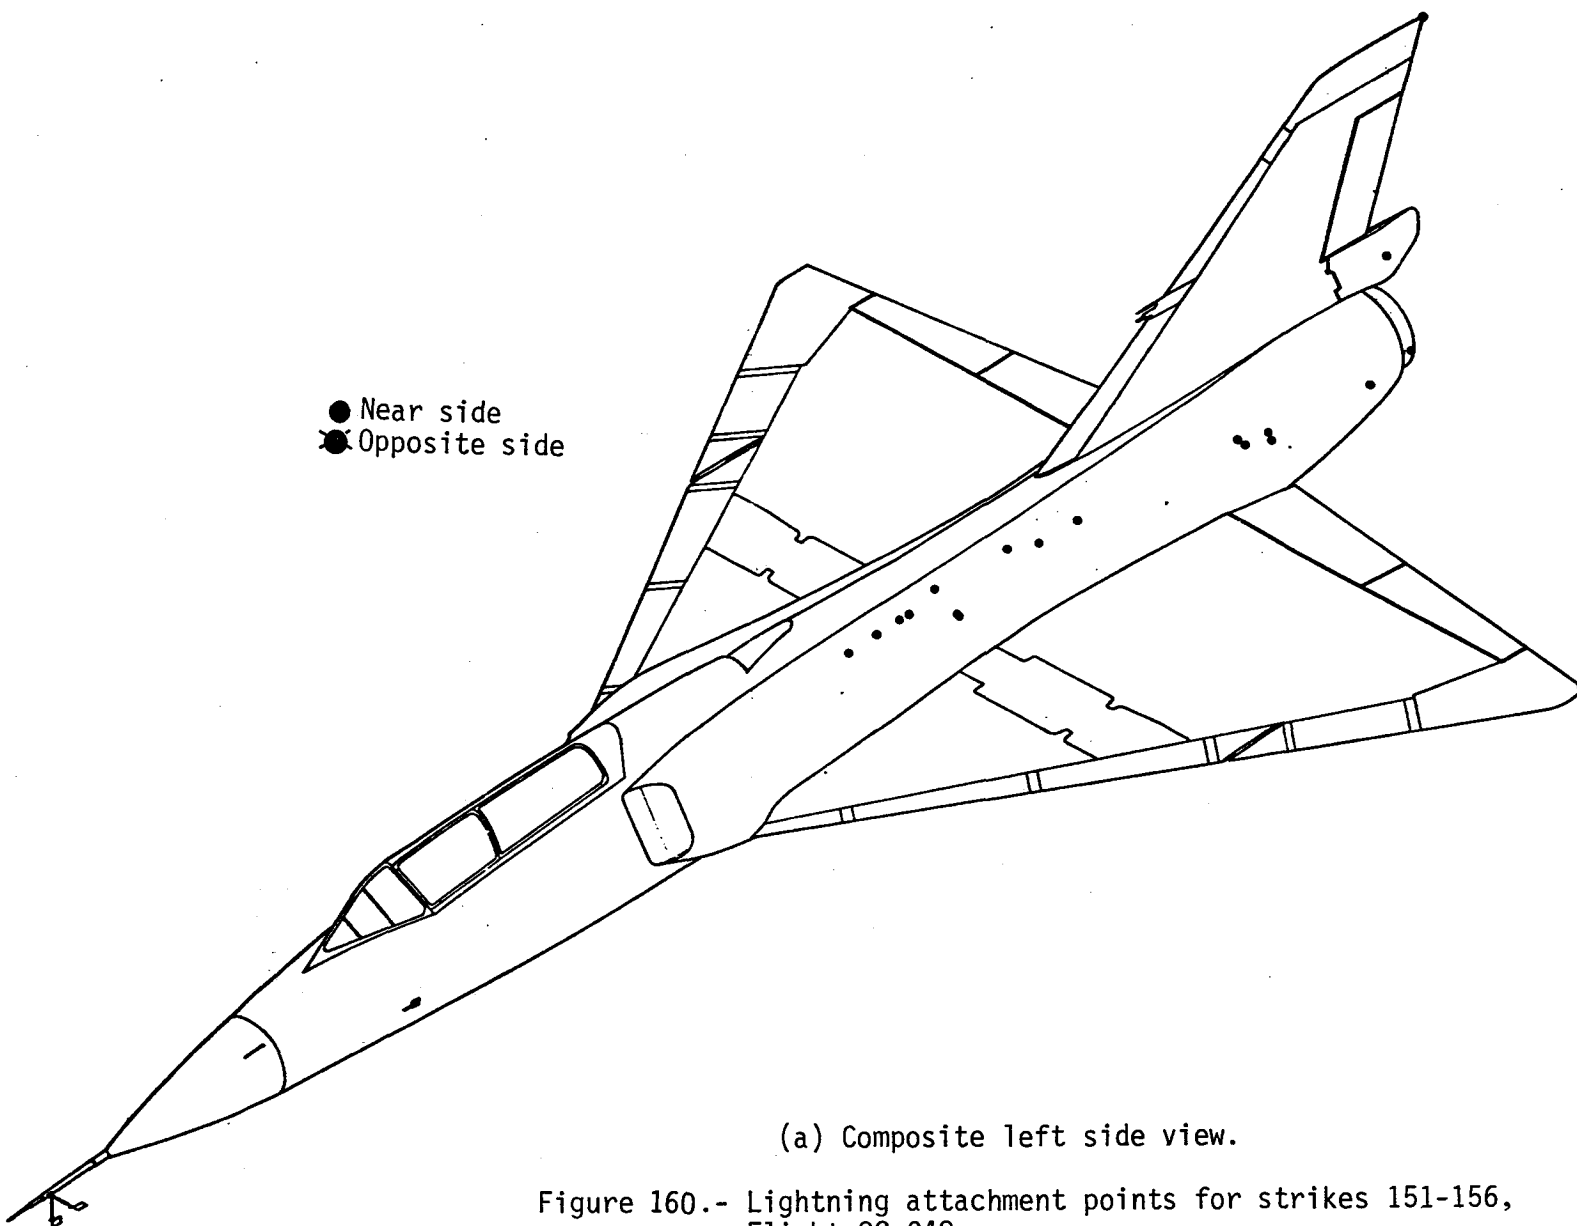
Figure 160.- Lightning attachment points for strikes 151-156,
Flight 82-048.

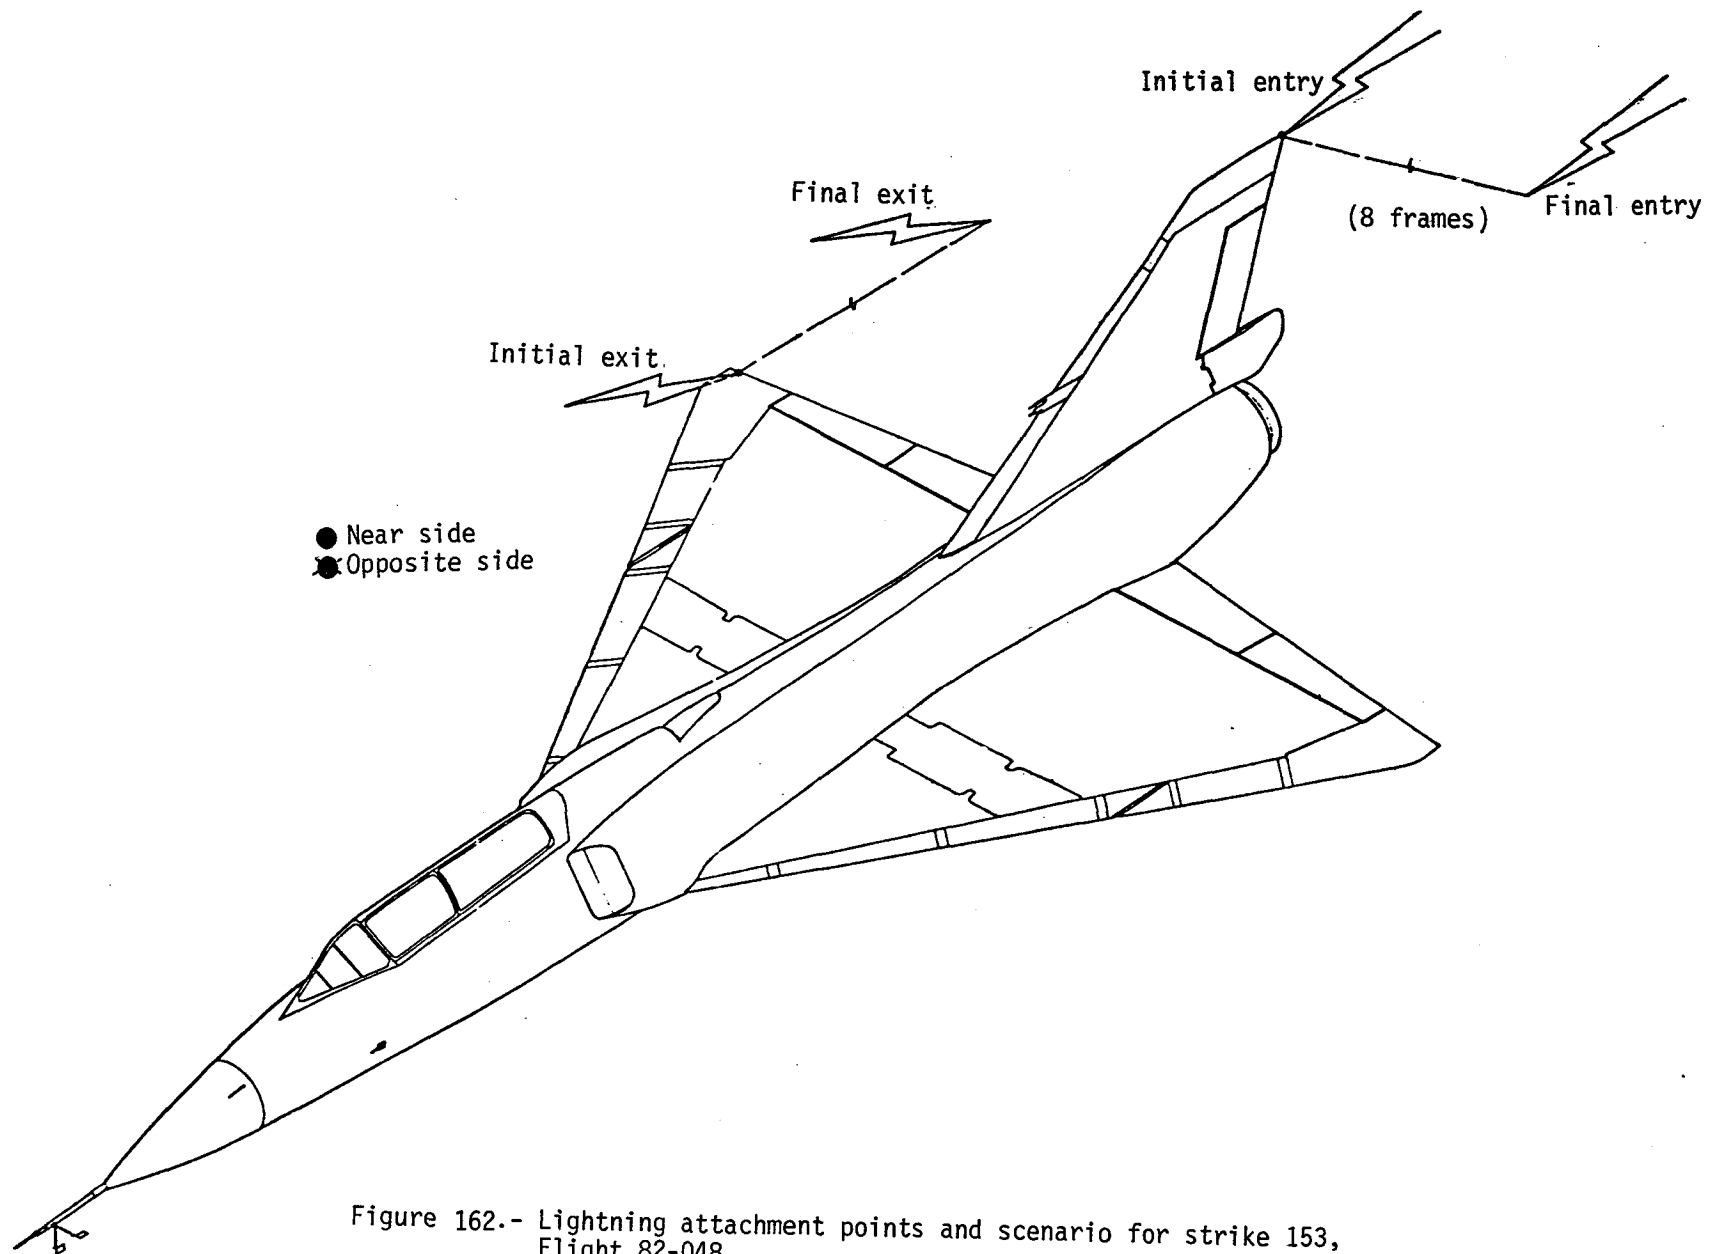
Figure 162.- Lightning attachment points and scenario for strike 153, Flight 82-048.

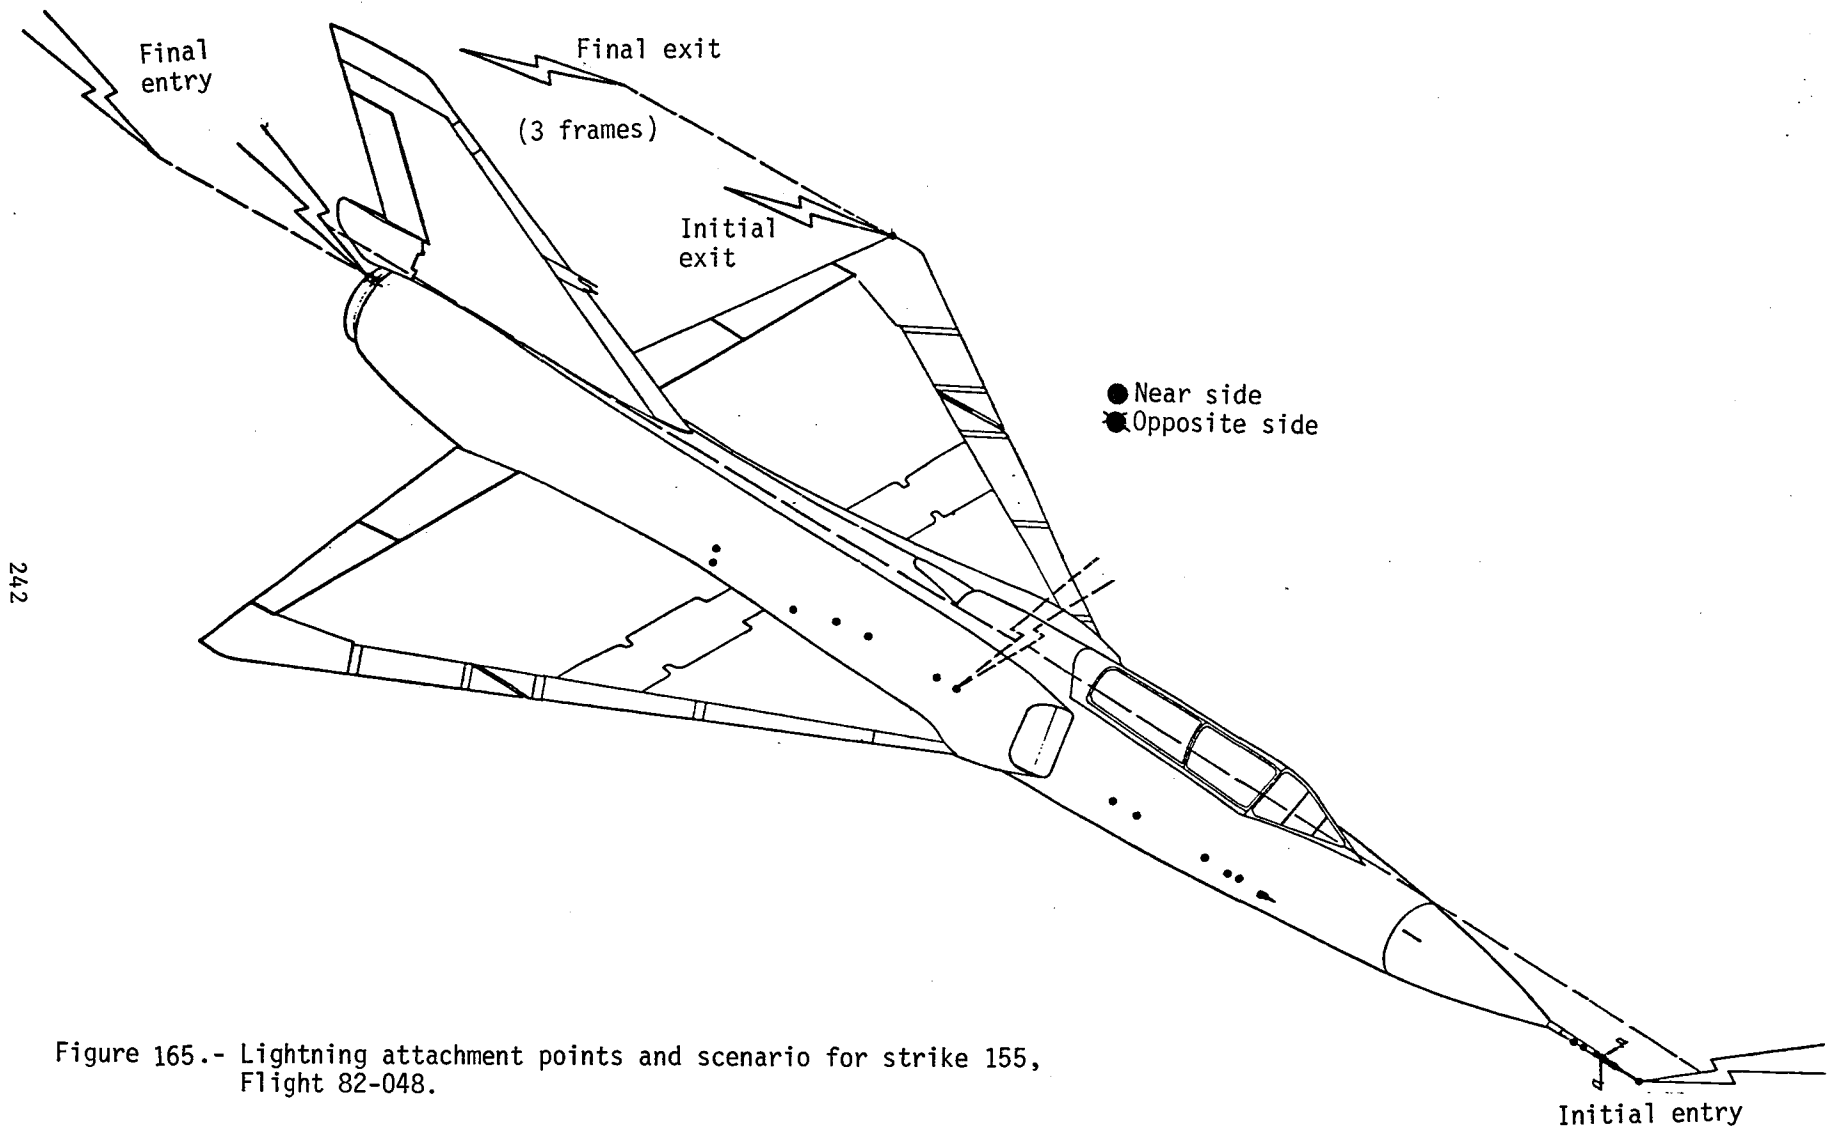
Figure 165.- Lightning attachment points and scenario for strike 155, Flight 82-048.

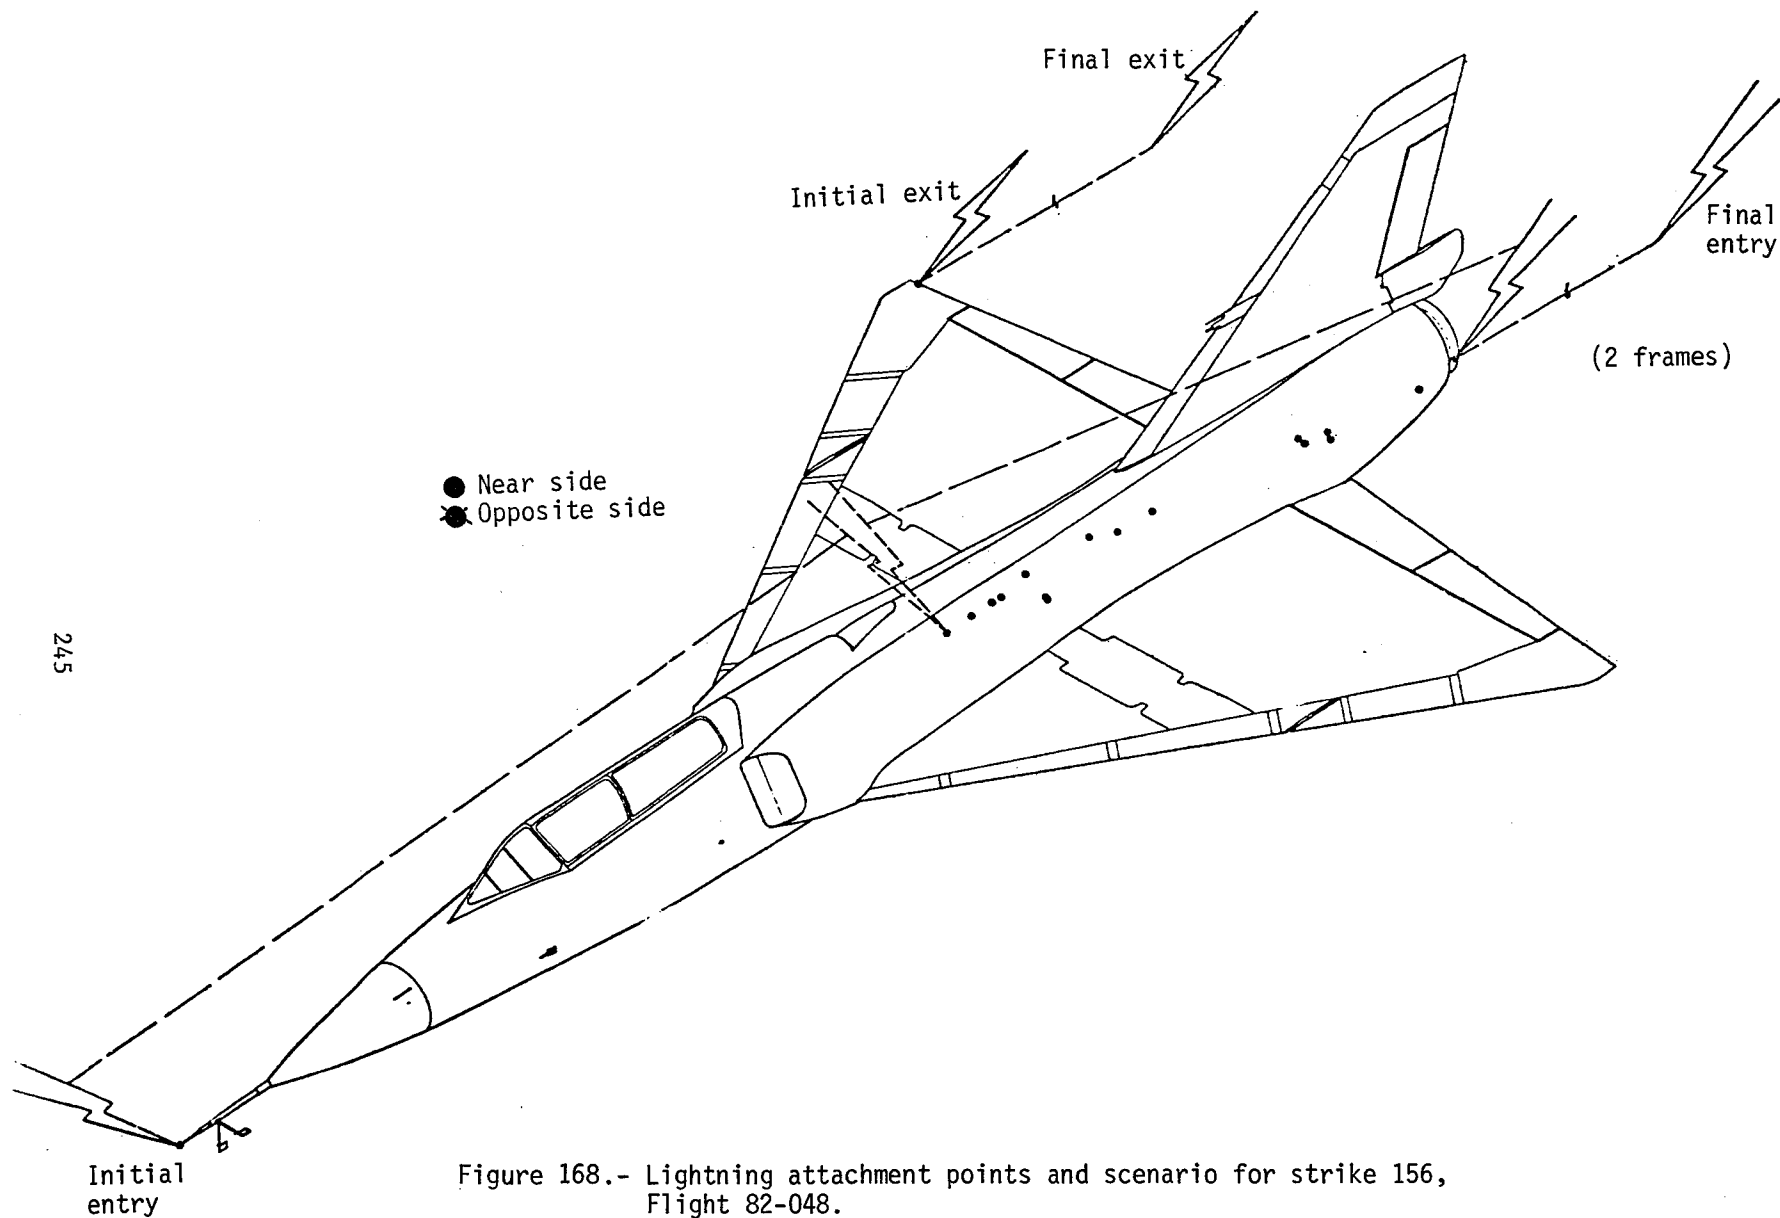
Figure 168.- Lightning attachment points and scenario for strike 156, Flight 82-048.
